Llanwern Rail Facilities - Phase 1 Planning

Ground Conditions and Contamination Report

September 2018

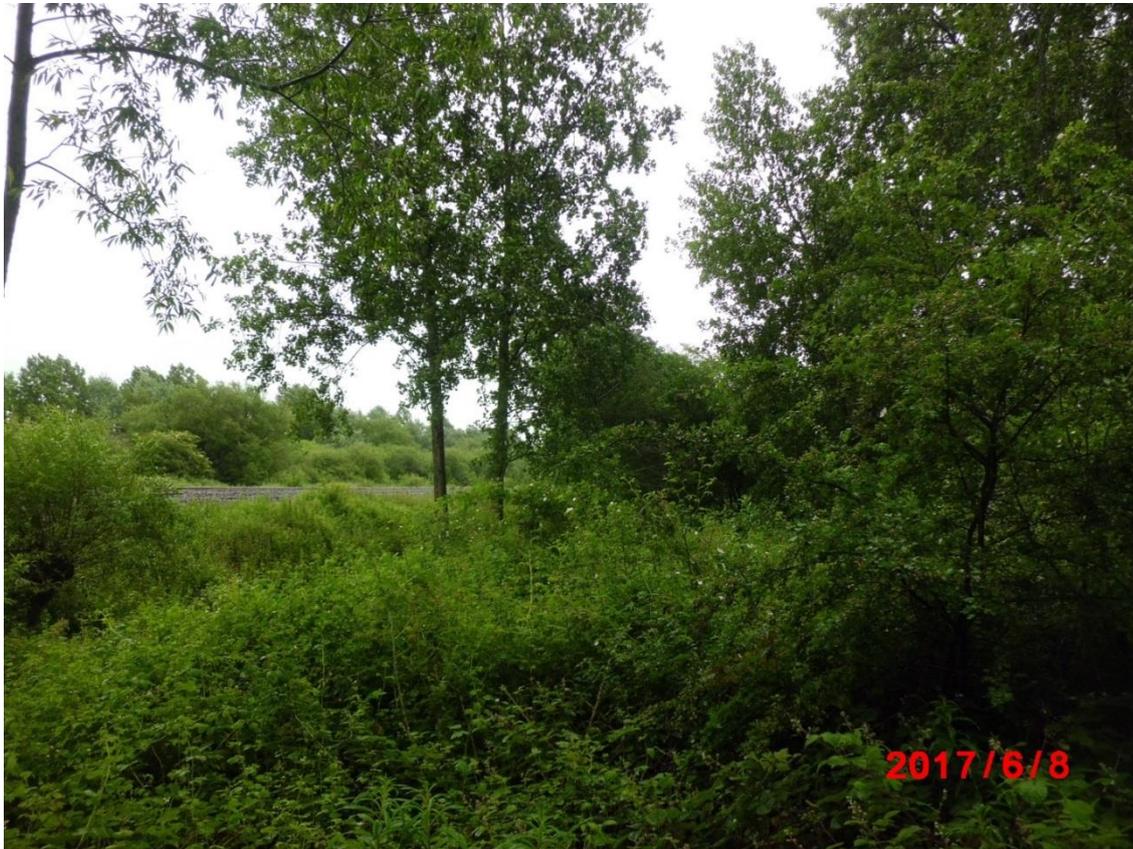
Figure 2.2: Location 1

Location 1 viewing north-east. Main line can be seen to the centre left, with the dense vegetation seen representative of what was encountered most of the Site.

Beginning the survey at the western end of the Site, dense vegetation was noted to be present. Figure 2.2 is taken from Location 1 providing an idea of the dense vegetation encountered. The vegetation is mainly comprised of trees and shrubs, which are dense enough to prevent continuous access through the Site. This density of vegetation is present across most of the Site, limiting the amount of information which could be gained of the Site during the walkover survey.

The Site is noted to be bounded by steep embankments rising to approximately 3.0m to 4.0m, to the north and south. The main line railway runs along the northern embankment and the Tata Steel service lines run along the southern boundary. In Figure 2.2 the main line can be seen to the centre left.

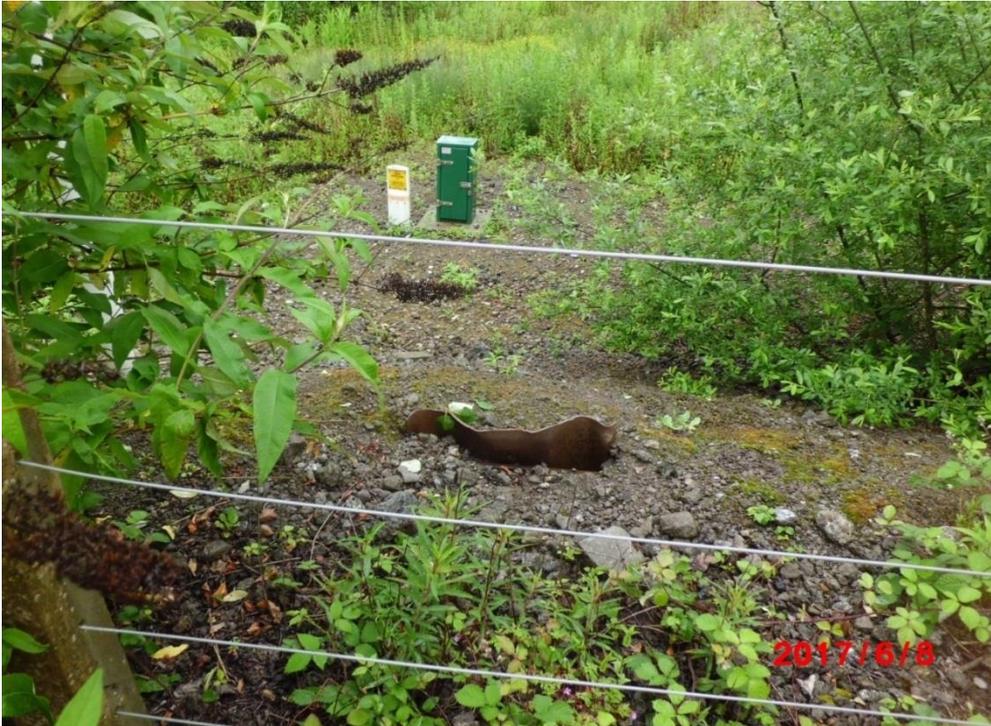
Figure 2.3: Location 2a

Location 2a viewing north. Gas pipeline signage in the upper centre of the image, along with sheet pile retaining feature at the centre of the image.

A buried high-pressure gas pipeline is noted at Location 2a (Figure 2.3). The directional alignment of the pipeline is unknown. Exposed sheet pile retaining features are also noted along the embankment to the service lines and suggest that their use is to act as a retaining structure to the embankment (Figure 2.4). The embankment to the service lines is mainly comprised of gravel, with cobble sized fragments dispersed amongst the gravel.

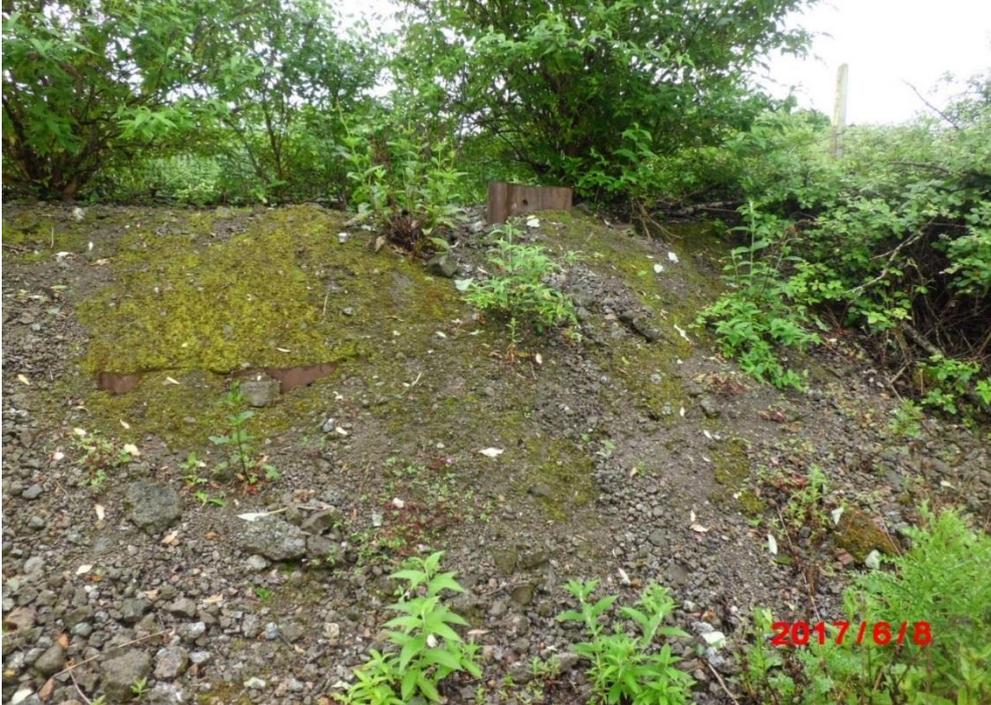
Figure 2.4: Location 2b

Location 2b viewing south. A view of the embankment and exposed sheet pile retaining structures

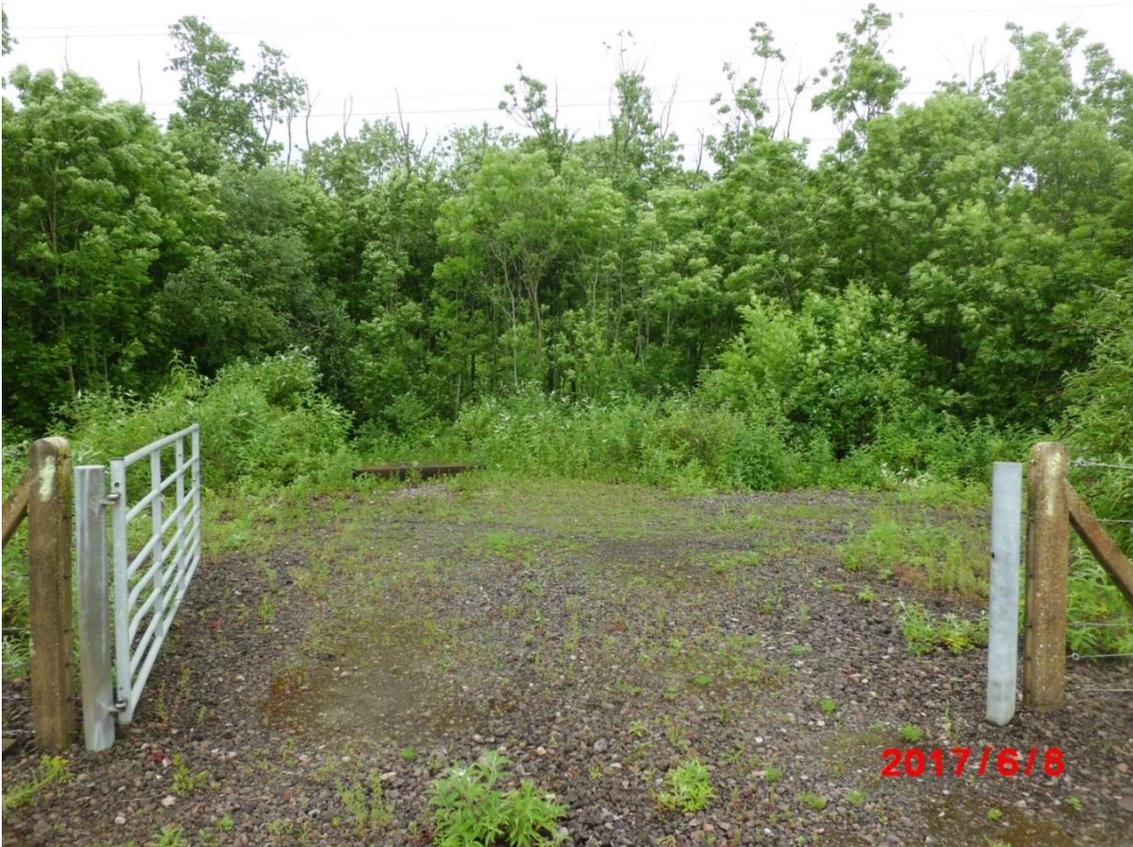
Figure 2.5: Location 3

Location 3 looking north. Gravel platform built on to the Site as a storage area for service line track repair.

A gravel platform is noted at Location 3 (Figure 2.5) and built on to the Site. Several of these platforms are noted to be present at irregular intervals, along the southern boundary of the Site and have been built using ballast to form a platform to the same topographic level as the service line. The platforms are used as storage areas for railway tracks, sleepers, and any associated equipment needed for the repair and maintenance of the service lines. The boundary of this embankment often slopes steeply onto the vegetated zone of the Site.

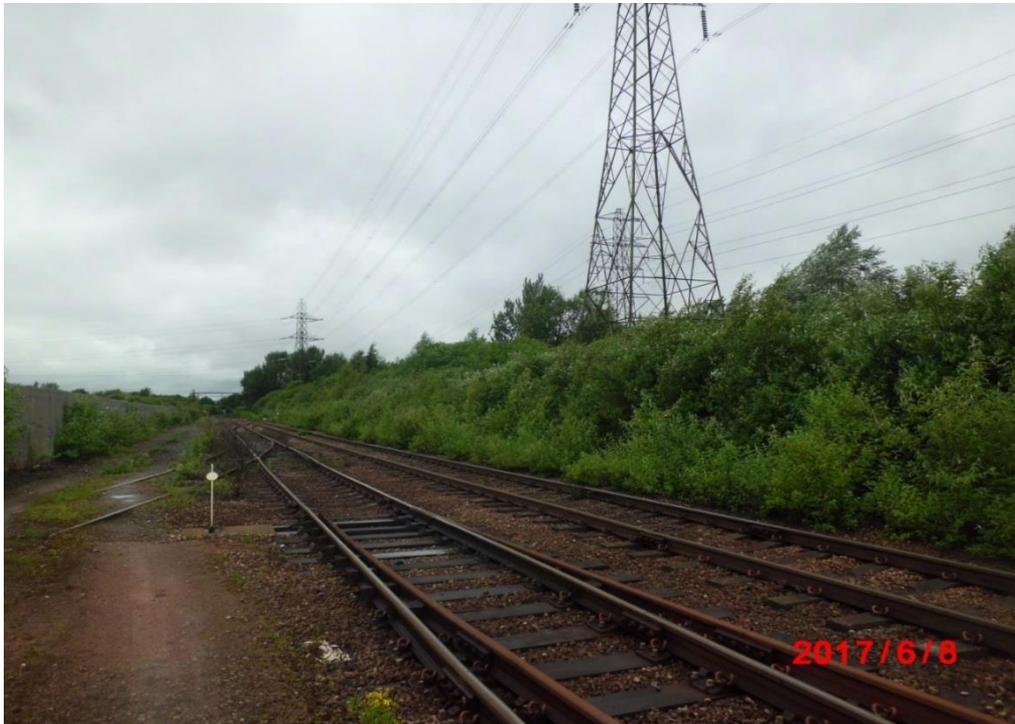
Figure 2.6: Location 4a

Location 4a viewing north-west. Provides a view of the service line, and Site towards the western boundary.

Figures 2.6 and 2.7 provide a view of the Site from the service lines, viewing towards the western and eastern ends of the Scheme. The images provide a view of the difficulty of access on to Site, due to the dense vegetation. Note the two 132kV overhead power lines which are present within the western half of the Site.

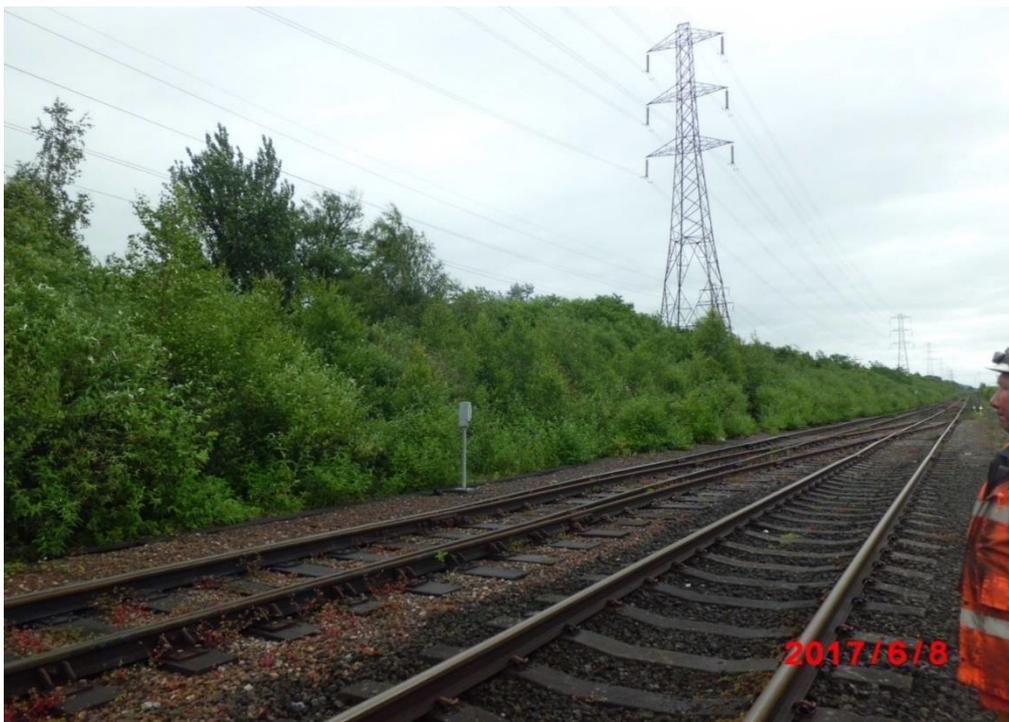
Figure 2.7: Location 4b

Location 4b viewing north-east. Provides view of the service line, and Site towards the eastern boundary.

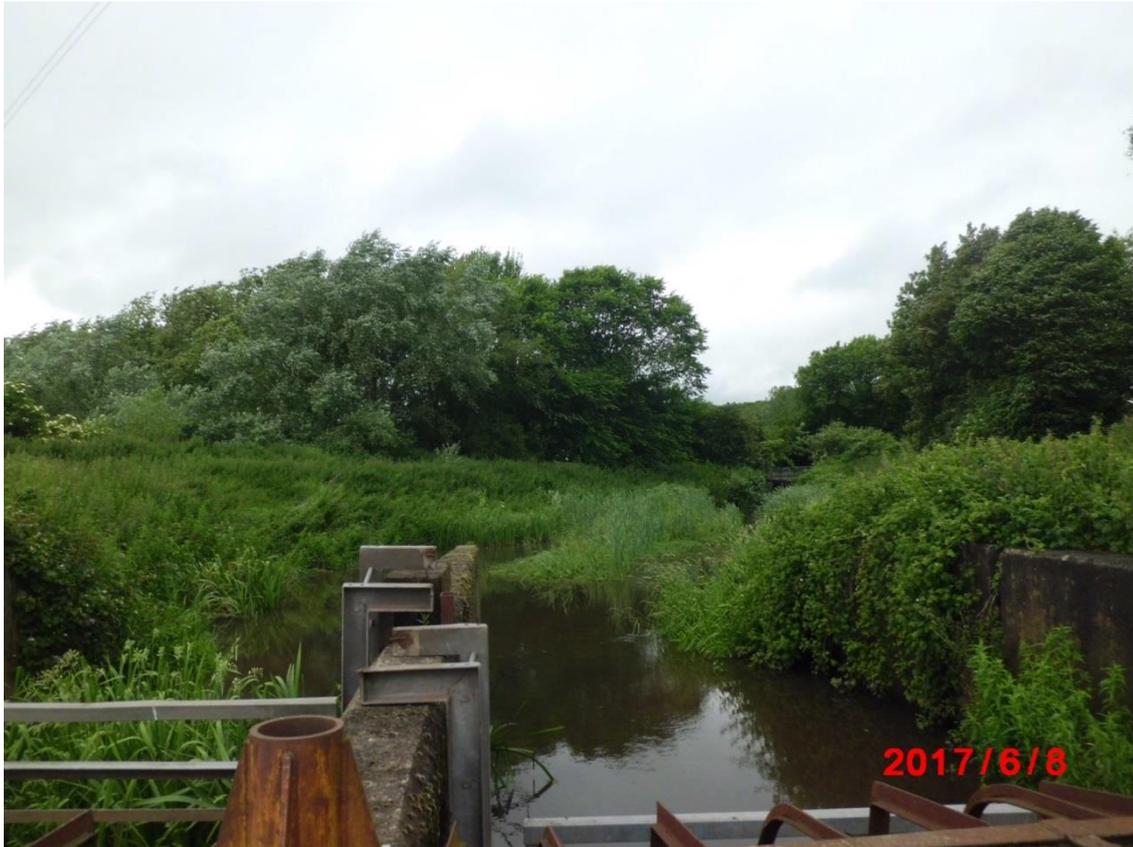
Figure 2.8: Location 5

Location 5 viewing north-west. View of Monks' Ditch. To the left of the image is an area of raised ground.

Figure 2.8 provides a view of Monks' Ditch looking north-west. Monks' Ditch is a canalised stream that flows north to south immediately to the east of the Site. Monks' Ditch flows through a concrete channel and is culverted under the main line and under the sidings. The embankments on either side are raised above surrounding ground level. Plans of Monks' Ditch and the other drainage ditches on-site are presented in Appendix A.
