Autumn 2019

Joint Review of Autumn Preparations and Delivery

CONFIDENTIAL
DATE: 15/01/2020

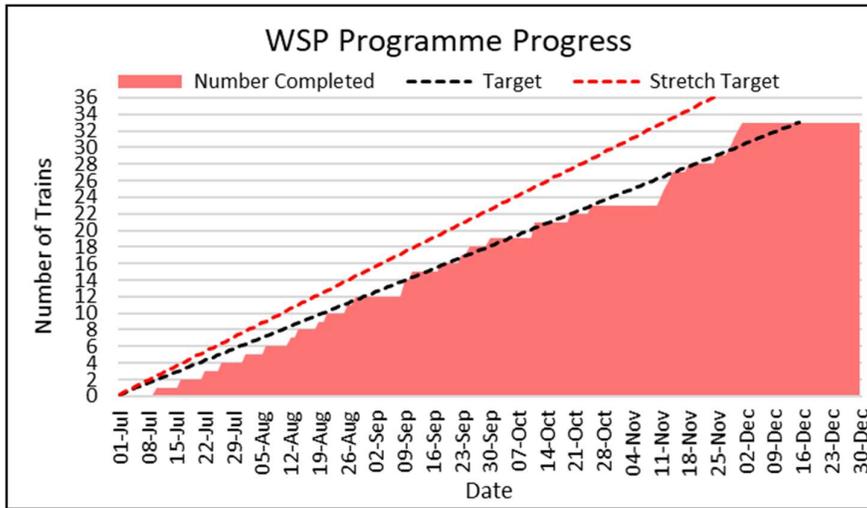
By the end of November, all planned Class 150 units in service had successfully undergone fitment of this technology (33 units). The remaining 3 units were planned to be out of service for the duration of the Autumn season due to 2 units undergoing 'Persons with Reduced Mobility' (PRM) modifications and 1 unit on long term stop as a result of a significant tree strike.

Figure 5 WSP Programme Progress Chart

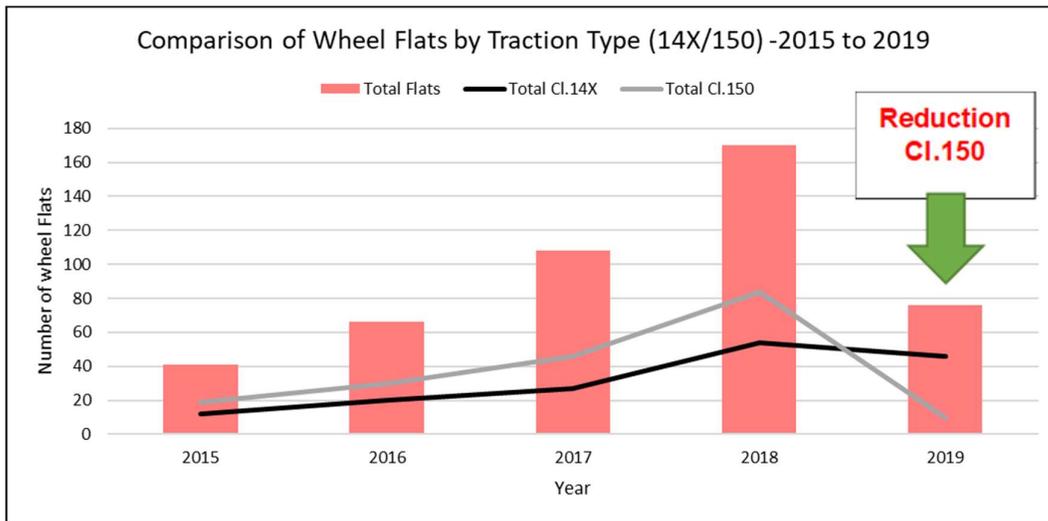
The success of this programme can be quantified by the number of Class 150 units suffering wheel flats. This year, **10 units developed wheel flats, compared to 84 units in 2018**. This equates to an 88% reduction which contributed to an overall reduction of wheel flats observed across all fleet types. It is worth noting that the 10 units involved were not fitted with WSP at the time wheel flats occurred.

Figure 6 Chart showing number of wheel flats developed over last 5 years

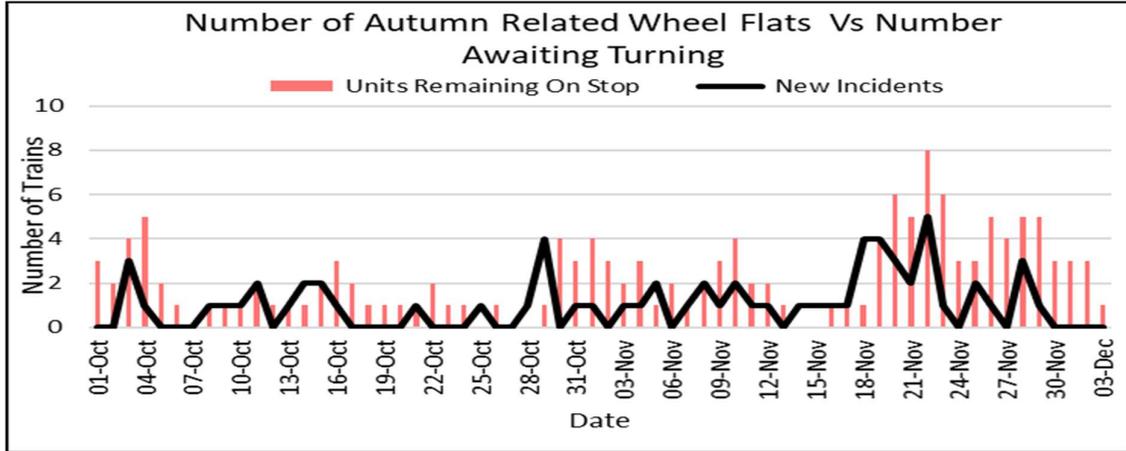
Figure 7 Chart showing number of units stopped for wheel flats vs awaiting tyre turn

The above chart (figure 4) shows the demand for tyre turning between the 1st October and 3rd December. Throughput is observed as being steady throughout the season, though at the beginning of November, severe flooding trapped a small number of trains which prevented them being turned within the usual 2 days, but these were quickly recovered.

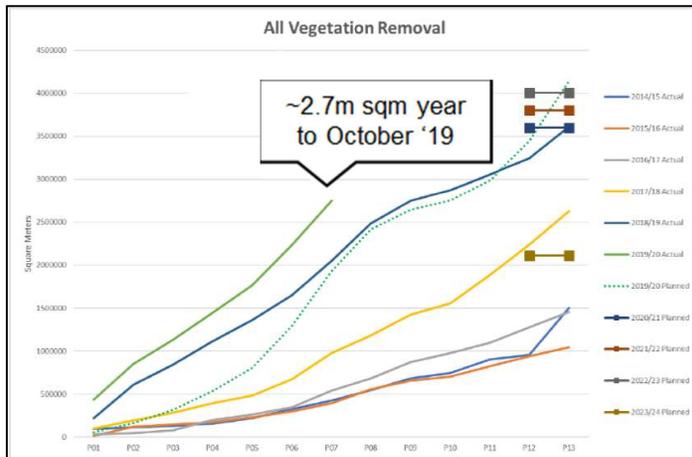
Vegetation management has been increasing year-on-year, and for 2019 ~2.7m sqm were managed through a range of work activities prior to autumn. Through the work of the 'Vegetation Management Joint Working Groups', 50 sites were initially identified for low adhesion risk and included in the route vegetation management plan for completion by the end of October with a further 14 sites were later included in the plan. Funding was re-distributed, and an additional £850k was secured, enabling all 64 sites to be delivered as planned and provide greater focus on managing lineside vegetation in relation to the wider safety risk to trains and passengers.

Figure 10 Chart showing current and planned vegetation clearance volumes (2014-2024)

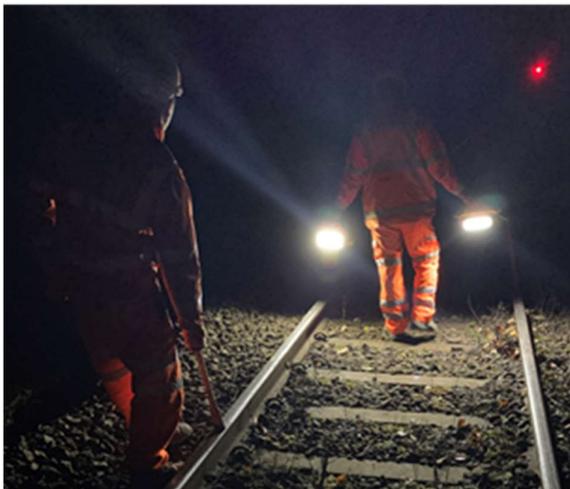
In 2019, NR invested an additional £600k on 12 dedicated 'Autumn response teams', which were deployed at 6 strategic locations across the network to enhance response capabilities and improve intelligence on emerging risks. The provision of this additional resource resulted in a 1300% increase in proactive inspections (2498 in 2019 v 178 in 2018) enabling mitigation activities to be more proactive and dynamic, consequently helping to minimise operational incidents and deliver a safer and more reliable service for our passengers.

Figure 11 Picture shows Autumn Response Team undertaking proactive inspection.
